## **Academic feasibility study:**

### Testing of a method for insulation of masonry and lath walls in existing Domestic Scottish Construction

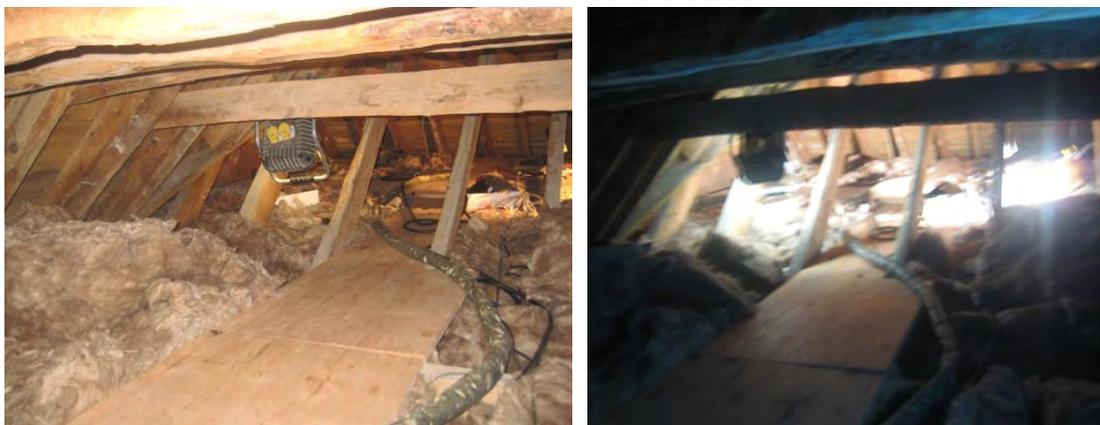
- Before the arrival of the team in charge to implement the insulation operation, we made sure to prepare the site. The site preparation involved the installation of boards in the loft; installing some lighting as this was not in place before; the removal of the skirting boards and removing all the dust that might have gathered in the wall cavity in the last 2 centuries.

**Floor covering and lighting installed for safety and easy access to the loft**

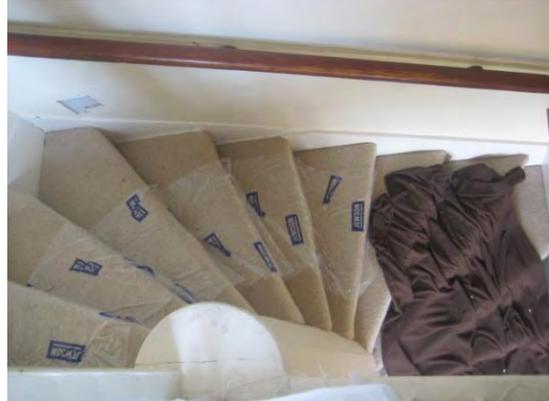
- Using industrial vacuum cleaner debris from behind the skirtings were removed to leave the cavity wall as clean as possible to avoid any thermal bridge.

**Stairs and corridors where covered to as many people were on site and lot of movement in and out the premises took place.**

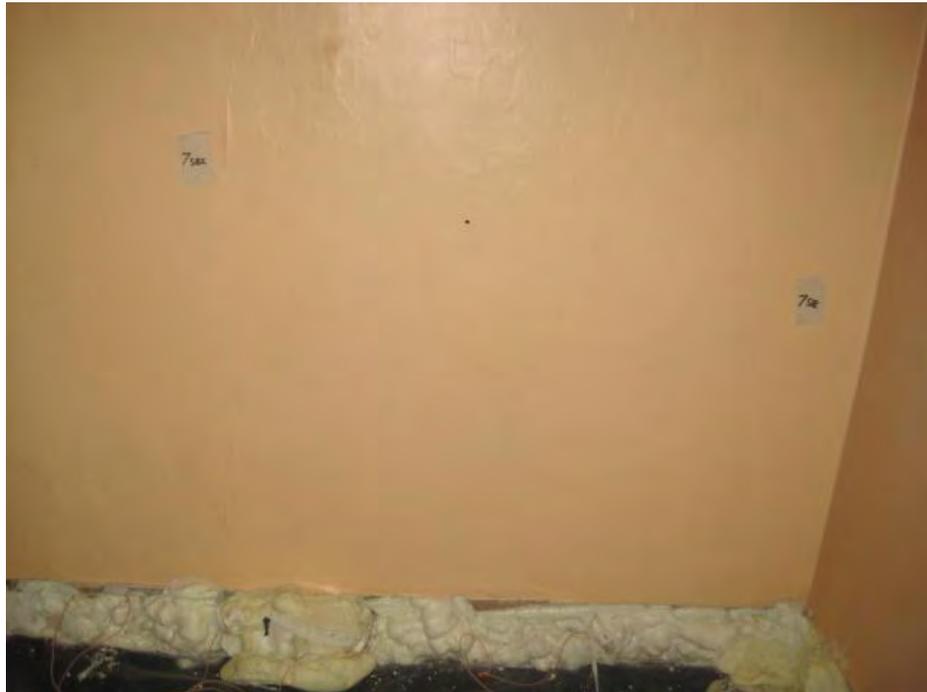
- Pour foam was then injected down the pre installed pipes in durations of 10 seconds, the pipes were withdrawn 500mm after each injection and blown through with the airline. The process of injecting alternate bays was adopted to ensure the least possible outward pressure was applied to the wall. The wall was monitored at all times for movement. It was noted that there were small areas where the pour foam

**Leak of the foam at the bottom part of the wall**

leaked out while still in liquid form, these areas were plugged using expanded spray foam pieces.

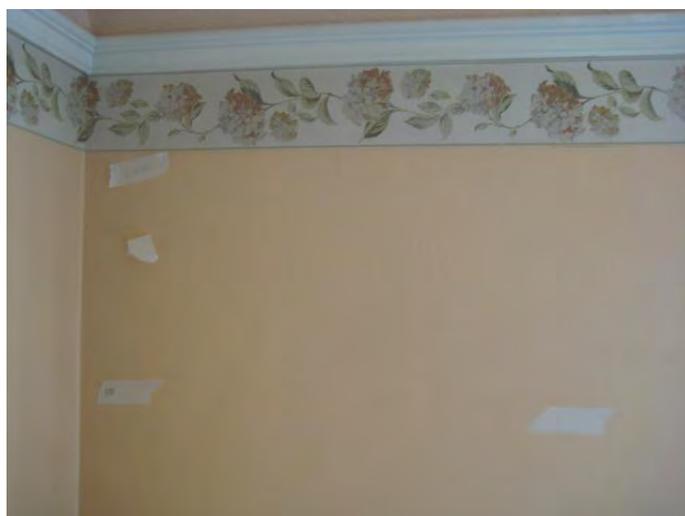
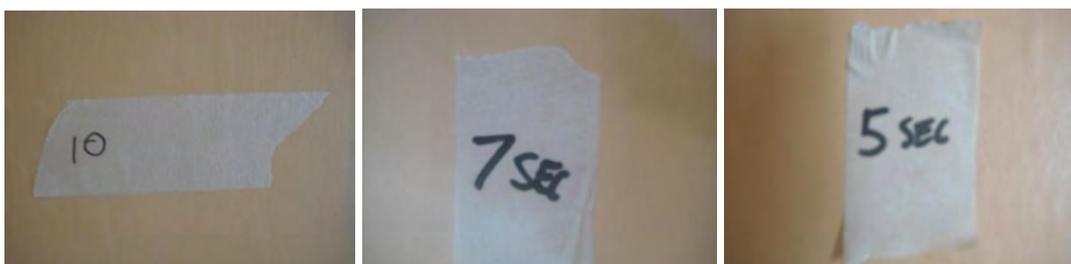
**Alternation of bays and localisation of the foam level on the wall**
