## **Academic feasibility study:**

### Testing of a method for insulation of masonry and lath walls in existing Domestic Scottish Construction

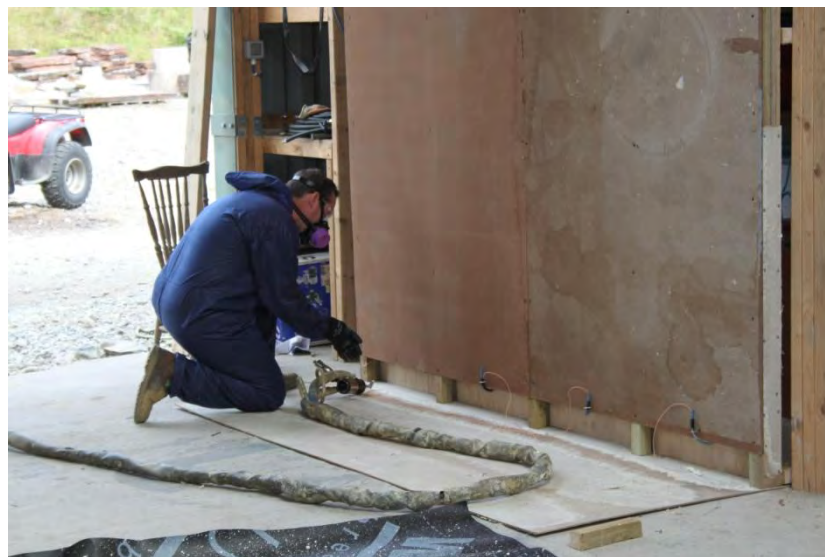
**Trial in the workshop**

Prior to the trial, lot of discussion took place between the researchers, local architects/SME and the company who agreed to supply the insulation material and its implementation using the proposed method agreed by the team. The agreed method was tested in a workshop by KDL on the 19th August before its application on the real wall. This trial involved the construction of a wall representing same characteristics of the real wall in term cavity dimension. The spray foam sealed the area behind where the skirting boards would be fixed, resulting in no loss of pour material. The pour material was capable of being injected down a 2800mm pipe and expanded vertically between and behind the vertical studs, leaving no voids. No deflection in the hardboard was detected. This trial was deemed to be successful, and a decision was made to adopt this method at house at Fettercairn

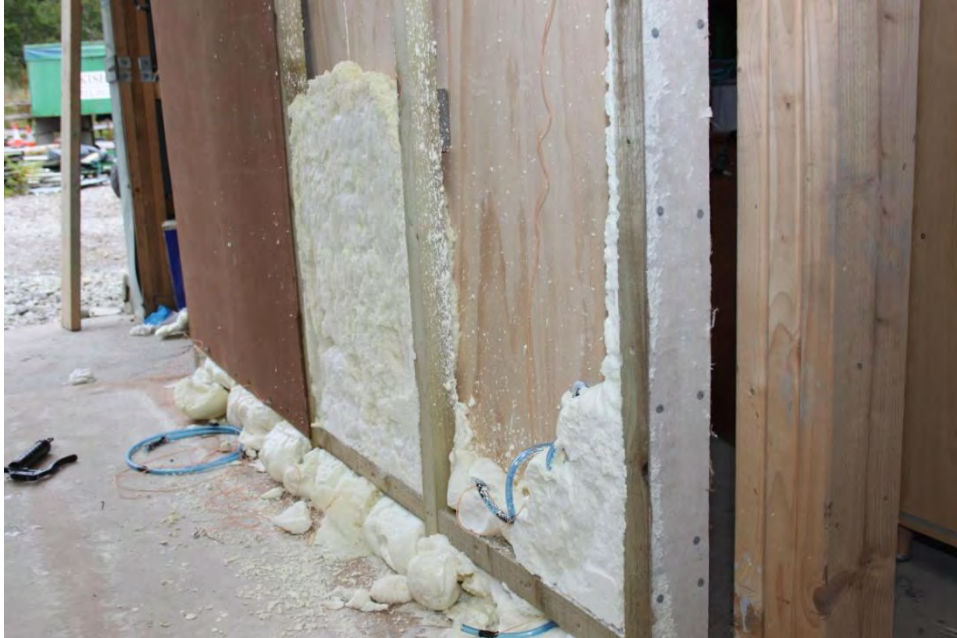
**Observation of the outcomes**

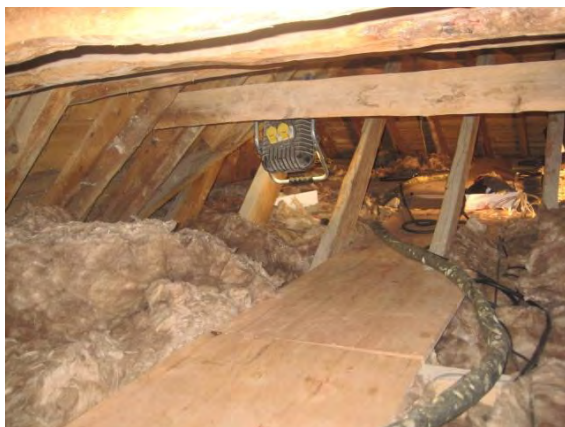
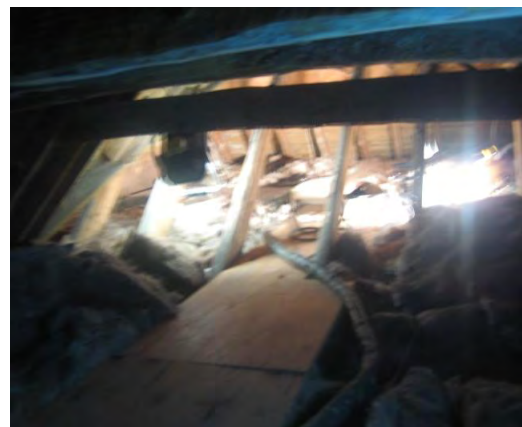
**Floor covering and lighting installed for safety and easy access to the loft**

- Before the arrival of the team in charge to implement the insulation operation, we made sure to prepare the site. The site preparation involved the installation of boards in the loft; installing some lighting as this was not in place before; the removal of the skirting boards and removing all the dust that might have gathered in the wall cavity in the last 2 centuries.

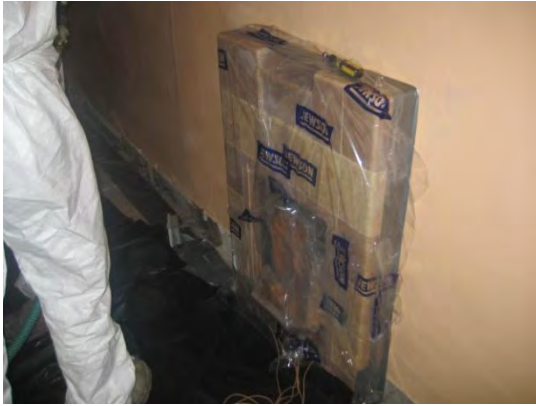
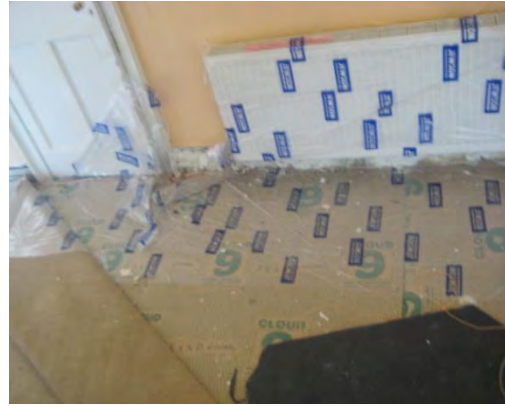
**Covering of the floors, features for projection against the foam that might be damaged by accident**

- Other preparations involved the carpet removal in the room that will be insulated, the covering of the floors in the corridors and staircase as lot of walks will happen during the trial that we didn't really know how long it will take.
- Covering all original features such as fire place and windows.

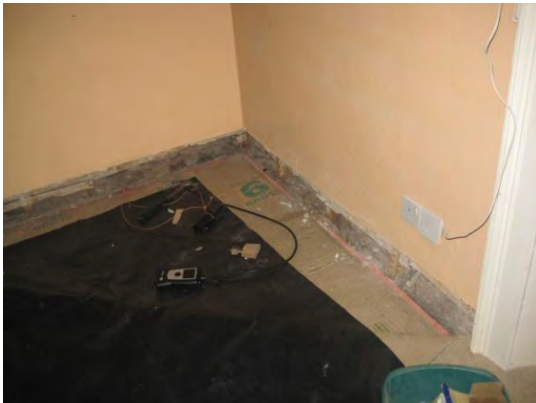
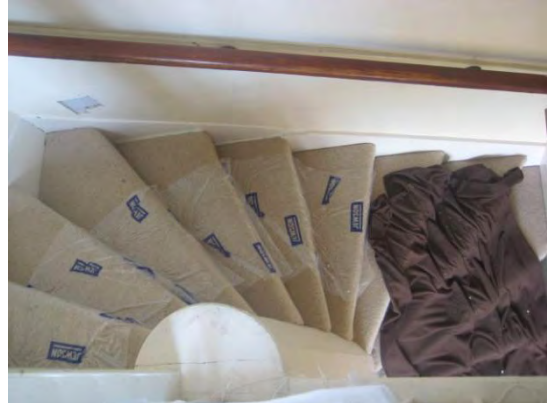
**Stairs and corridors where covered to as many people were on site and lot of movement in and out the premises took place.**

- Using industrial vacuum cleaner debris from behind the skirtings were removed to leave the cavity wall as clean as possible to avoid any thermal bridge.

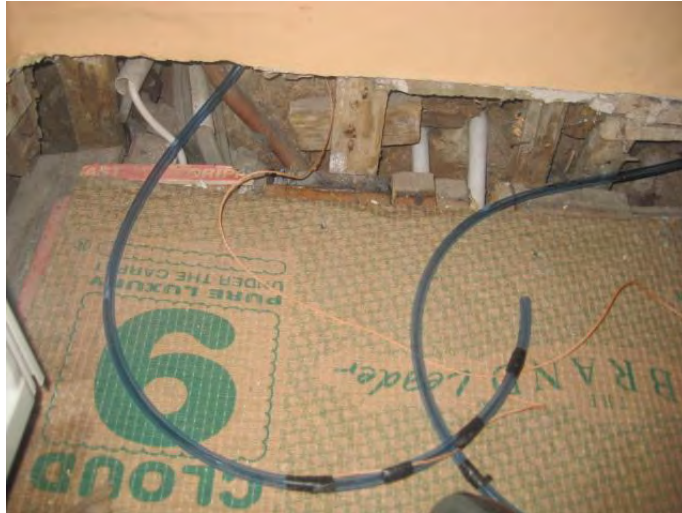
**Pipes attached to cords**

- The draw cords were attached to the 10mm polyurethane pipes and the pipes pulled down, and then retracted 200mm, then secured. A pipe was inserted between each stud. The site supply of polyurethane pipe ran out and the only available pipe, locally, of the same diameter was a PVC pipe, this was used to 4 bays. This type of pipe appeared later on to be more difficult than the previous one to work with.

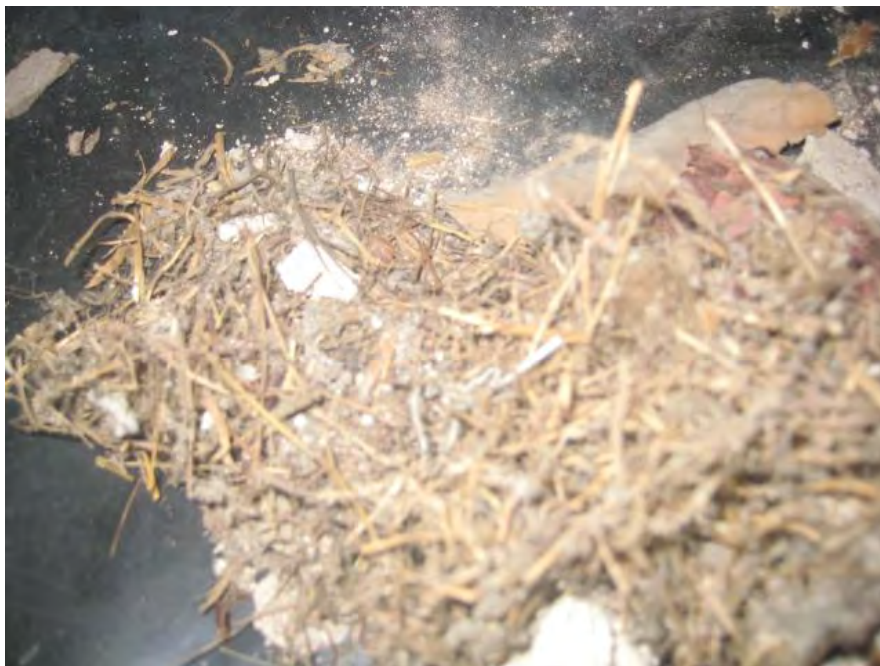
- As the pipes were installed it was noted that debris was falling down when disturbed. To ensure no bridge within the cavity was caused, which could lead to damp problems in the future, it was decided to clean the cavity. This was achieved by moving the fibreglass probes around to dislodge trapped debris, assisted by an airline inserted into the cavity. The result was that approximately a pale full of debris was removed, which consisted of plaster lumps, fine dust and wooden twigs, presumably put there by birds making nests. The void was then cleaned by vacuum and brushing.

**Sample of debris removed from the wall during this phase of the trial despite the cleaning prior to the start**

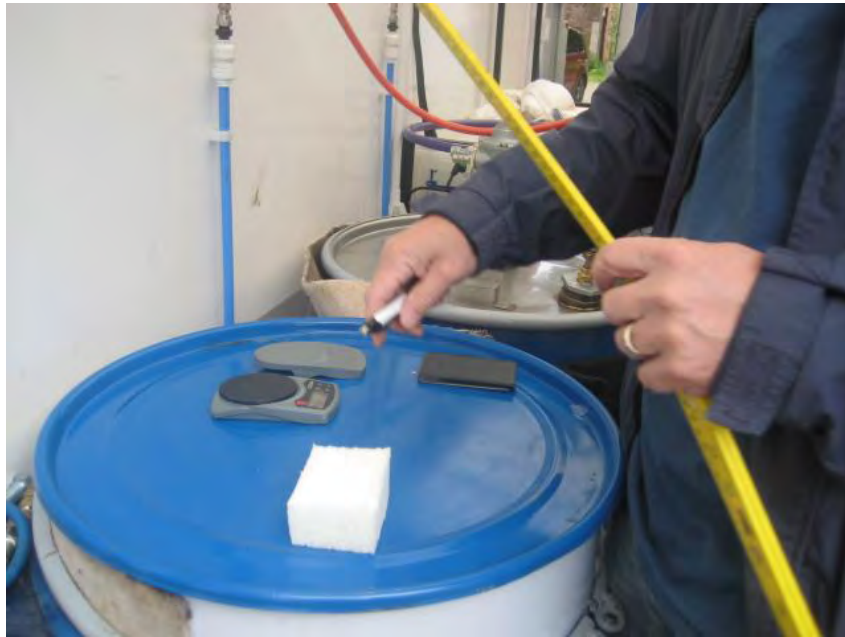
**Quality check of the foam**

- The equipment was changed over from the spray foam material to the pour foam material, and samples taken to prove the correct rate of expansion.

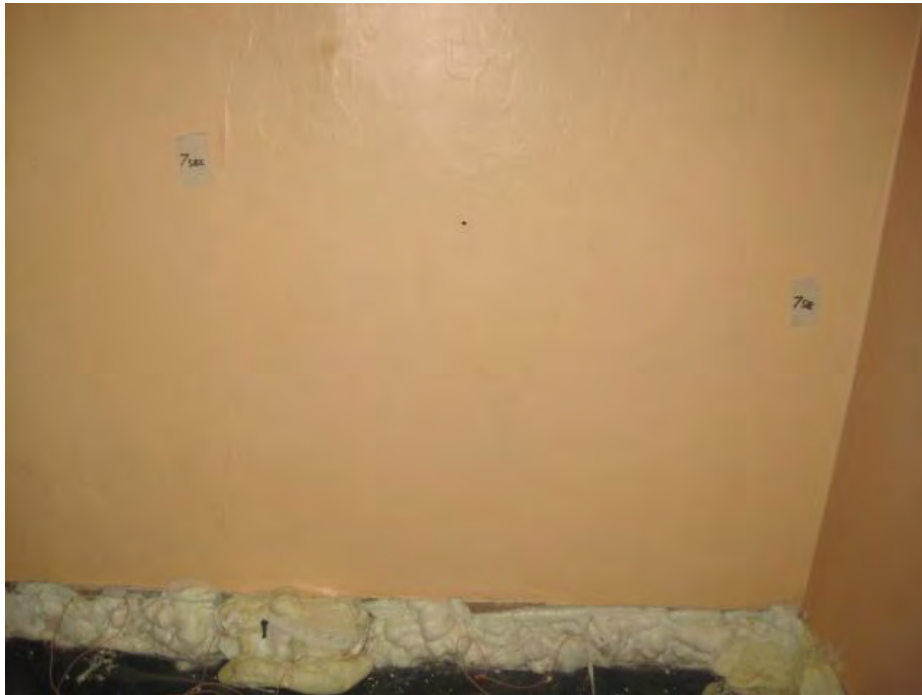
- Pour foam was then injected down the pre installed pipes in durations of 10 seconds, the pipes were withdrawn 500mm after each injection and blown through with the airline. The process of injecting alternate bays was adopted to ensure the least possible outward pressure was applied to the wall. The wall was monitored at all times for movement. It was noted that there were small areas where the pour foam

leaked out while still in liquid form, these areas were plugged using expanded spray foam pieces.

**Leak of the foam at the bottom part of the wall**

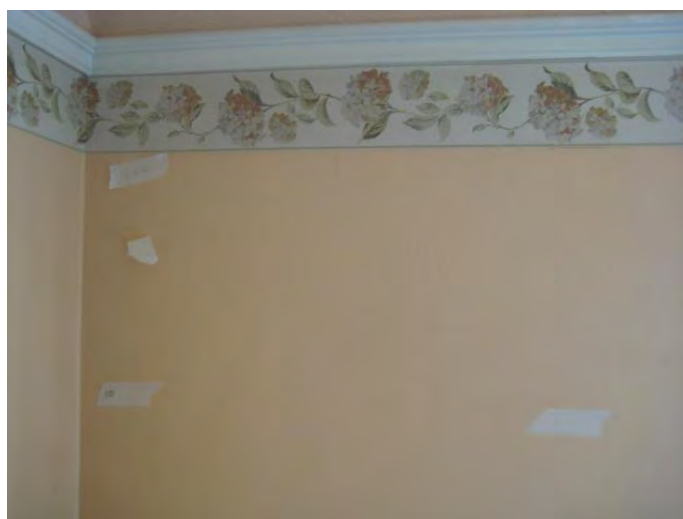
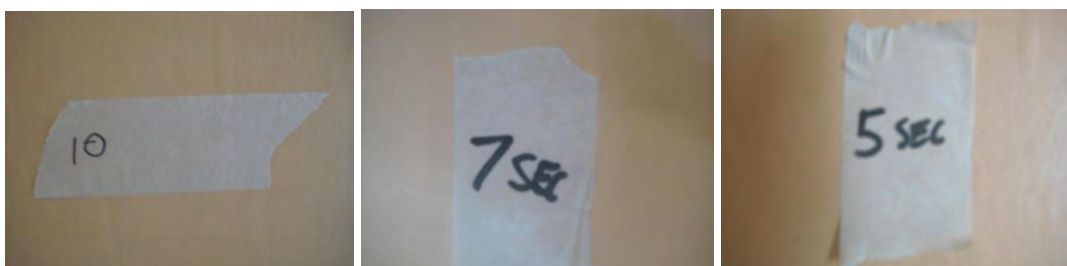
**Alternation of bays and localisation of the foam level on the wall**

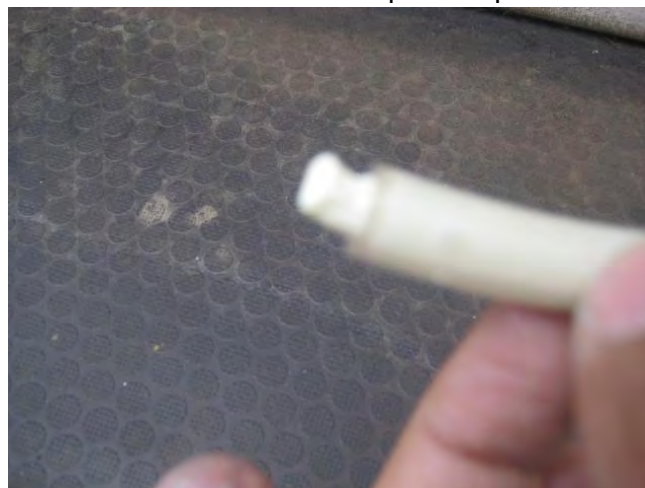
- 10 second Injections were then made to the missed bays, and the pipes blown clean.
- When all the heat created during the pour foam expansion, further 10 second injections were made to alternative bays. With the missing bays returned to when the heat had dissipated. It was found that the PVC pipe would not take a second injection without blocking, (which in turn caused a blockage in the gun), requiring four of the bays with polyurethane pipes to have the pipes removed and re-installed in the bays with the PVC pipes.
- This was achieved by taping the pipe to the fibreglass probes and inserting down the cavity while the injection took place. This method was also required in instances when the draw cords became fast within the expanded pour foam.

**Pipe blockage**

- During the trial it was discovered that the PVC pipe was not capable of more than one injection without blocking, and therefore not suitable for this application.
- The debris behind the lath and plaster should have been cleaned of debris before the draw strings and pipes installed. This would have made installing the pipes much quicker and easier.
- It was determined that in some locations the draw cords for the delivery pipe were not required and the pipe could be inserted, positioned and withdrawn while attached to the fibreglass probes. This would make the process quicker in certain circumstances.
- It was found that the Icynene insulation added rigidity to the wall.

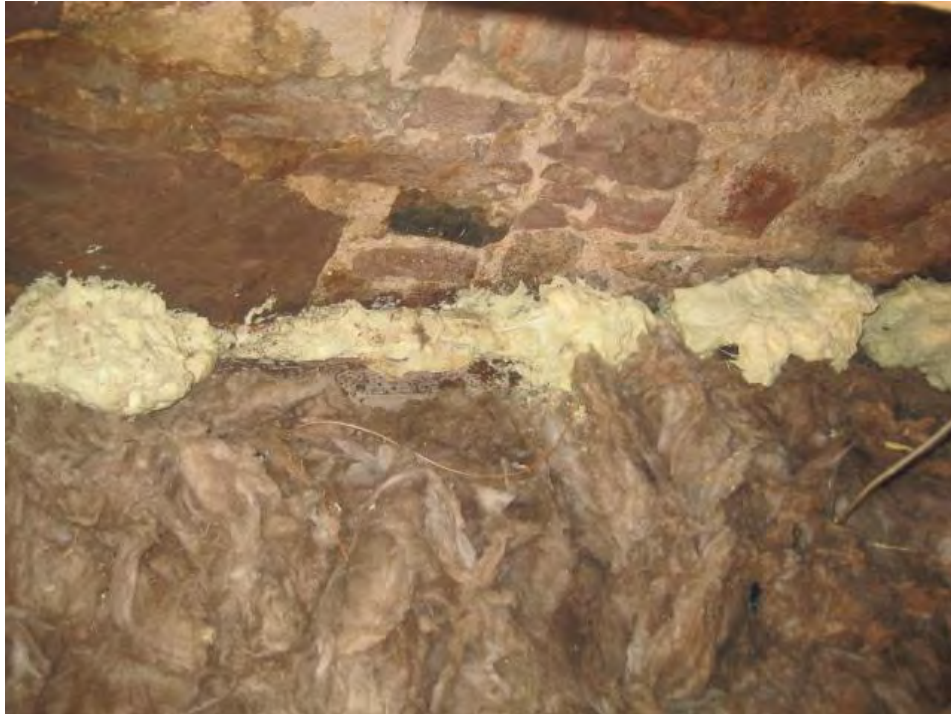
- The process was repeated until the pour foam was visible in the attic space. Once this was achieved the material was changed back to spray foam and in the area of the comb, spray foam was installed to join the existing fibreglass insulation to the newly placed Icynene.

**Top of the gable wall, foam seen from the attic**

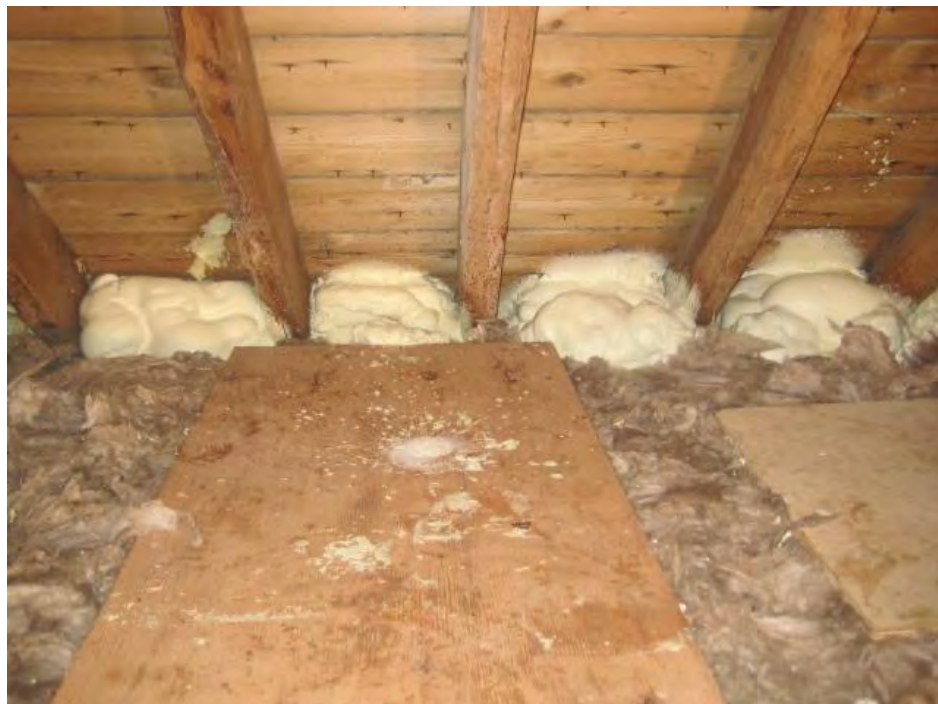
**Foam seen at the eave level**

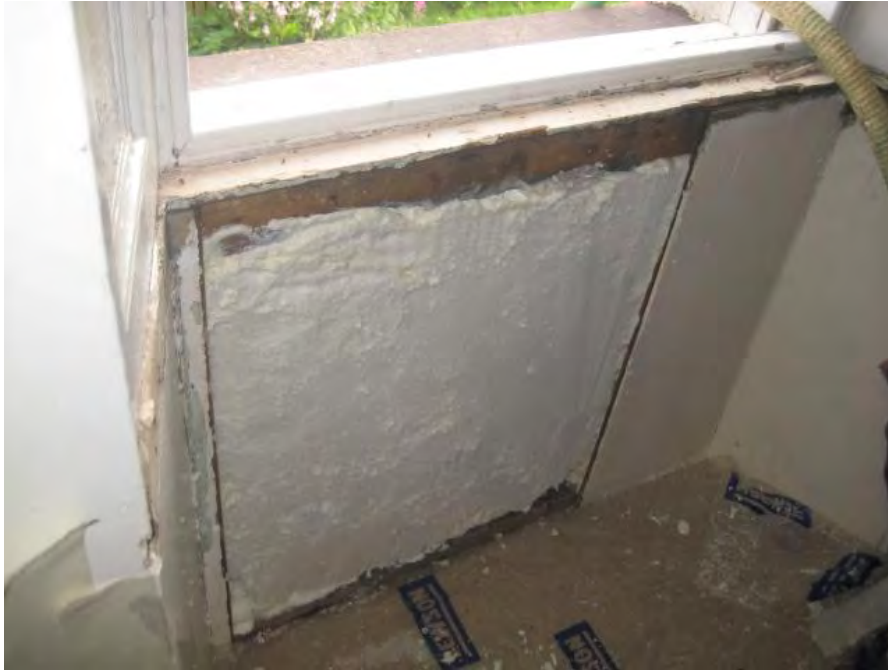
- Other area proven to be in need to be insulated was discovered during the trial such as under the window. The team decided to insulate it using the spray method.

**Insulating the wall under the window**
